NASA CR-121125  
MDC G4328

# CONTAMINATION AVOIDANCE DEVICES FOR POPPET-TYPE SHUTOFF VALVES

FINAL REPORT

January 1973

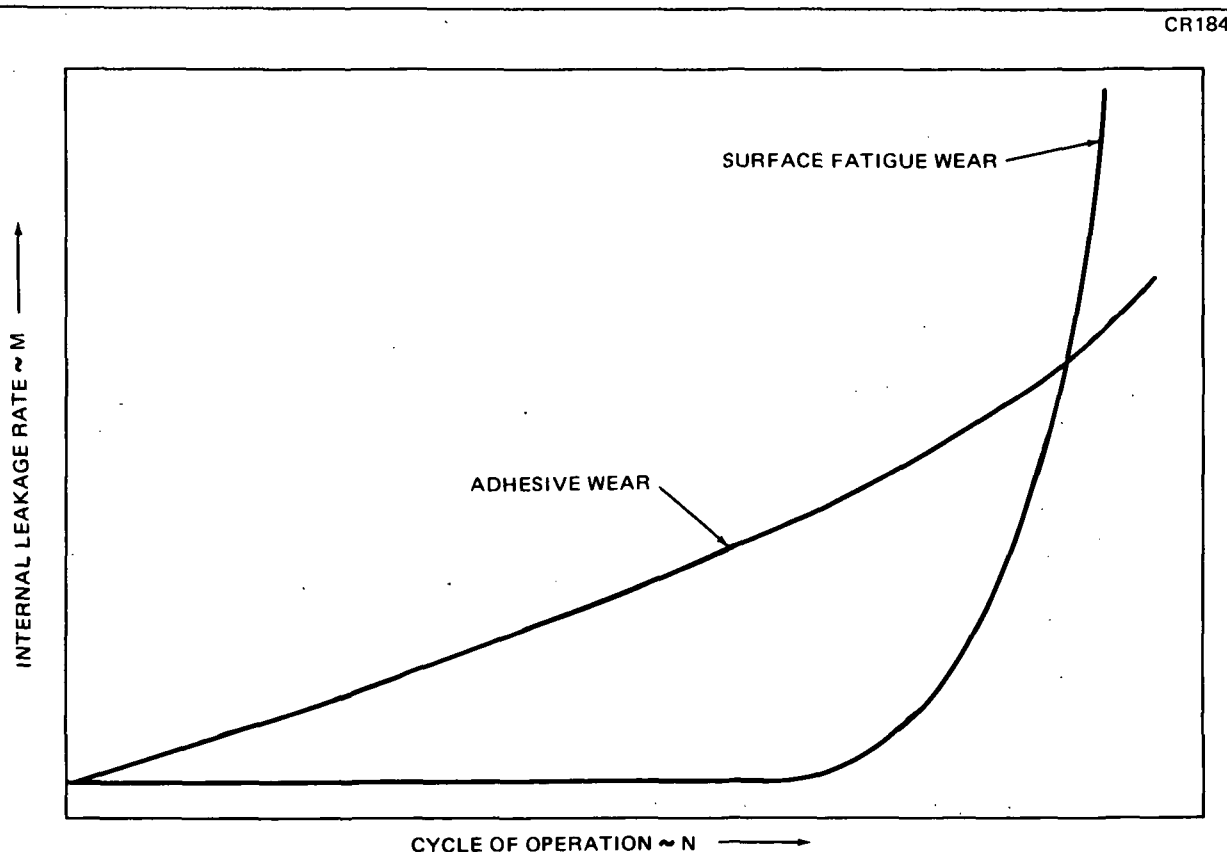
Figure 3-1. Leakage Characteristics of Valve Seal Closures

To provide the most useful data for component designers, the wear rates for the valves were expressed in terms of seal leakages across the main sealing closures instead of the mechanical wear rates (i. e. change in dimension). By comparing the rate of change of the internal leakage with cycles of operation, an adhesive wear failure could be separated from a surface fatigue failure. A surface fatigue failure was expected to be entirely different from an adhesive wear failure. Surface fatigue should show little or no change in leakage for a relatively large number of cycles and then should produce a sharp increase in leakage in a short time as shown in Figure 3-1. Adhesive wear would be expected to start with the first cycle and continue at a linear rate during the total period of operation. A combination of these two wear mechanisms can occur, and under these considerations the surface wears in the adhesive mode until the surface area loss is sufficient to reduce the total surface area to a value which will no longer adequately support the applied seat loadings. Hence, surface fatigue starts, and a rapid increase in leakage occurs after a relatively small number of additional cycles.

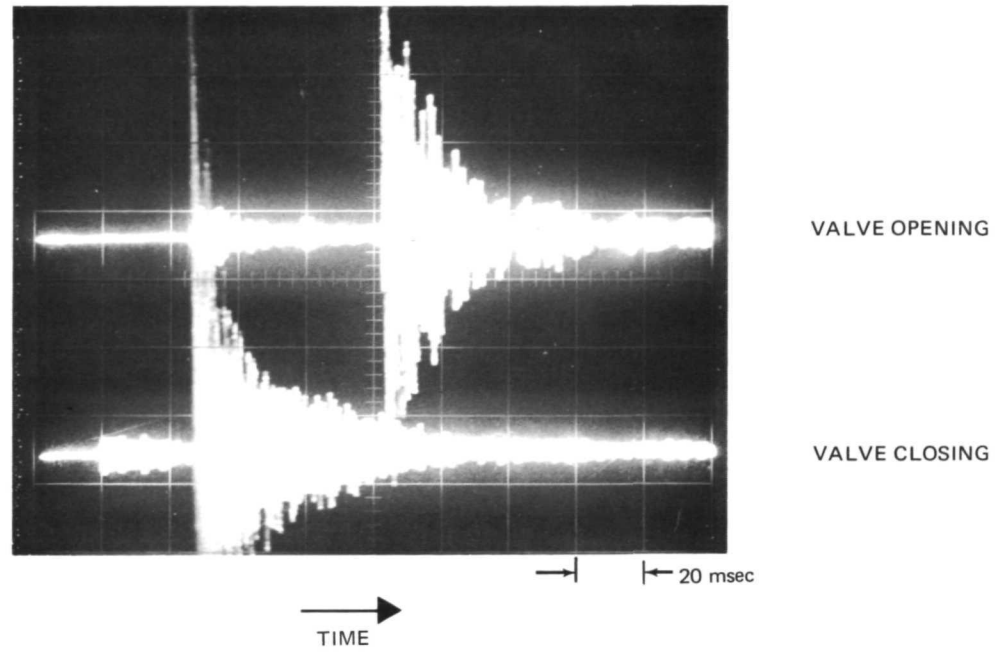
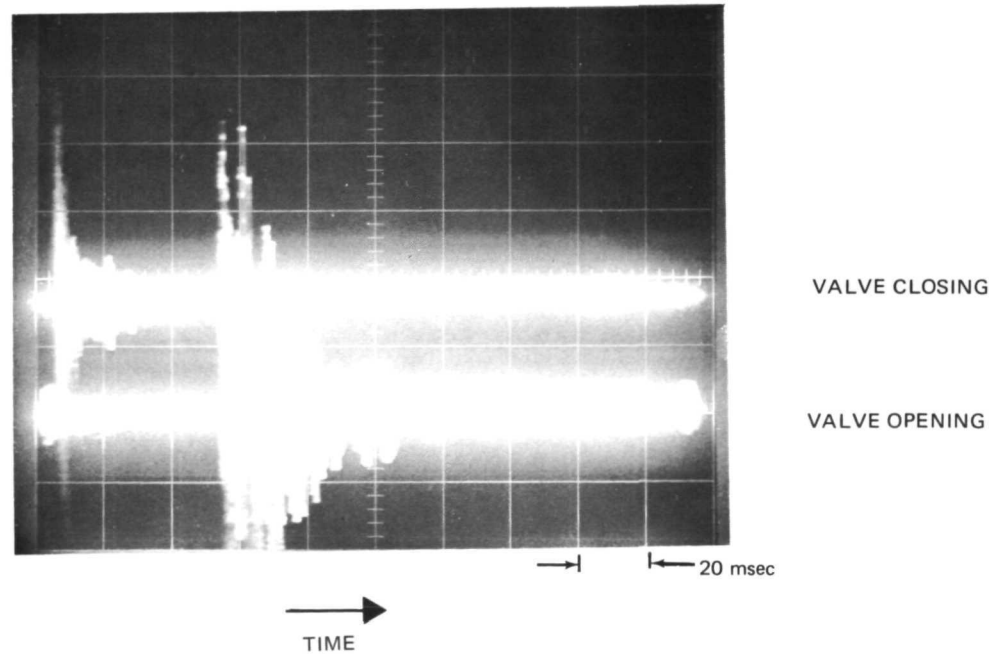
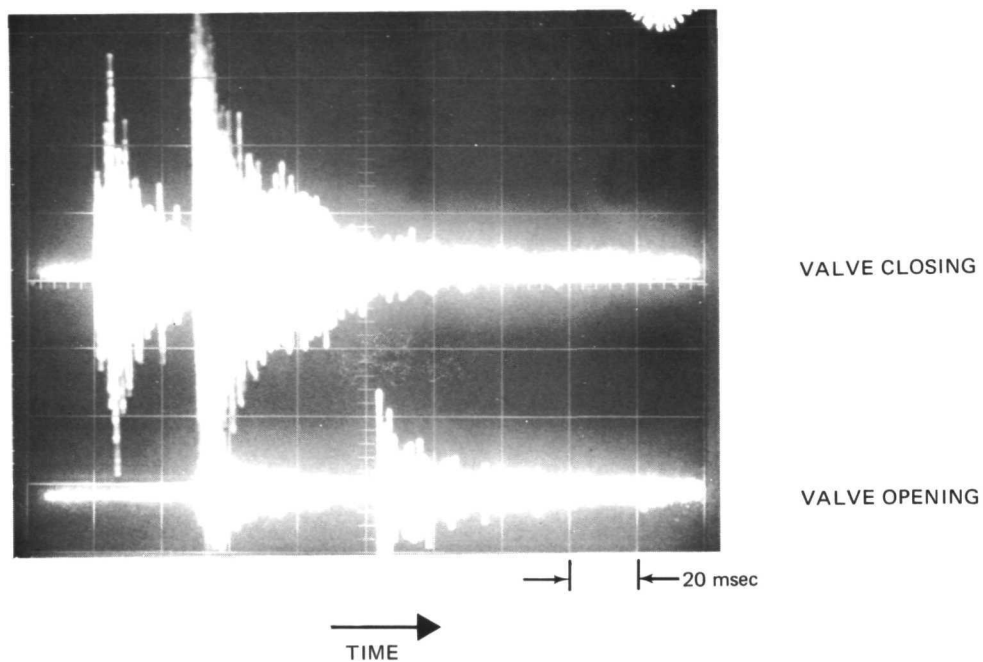
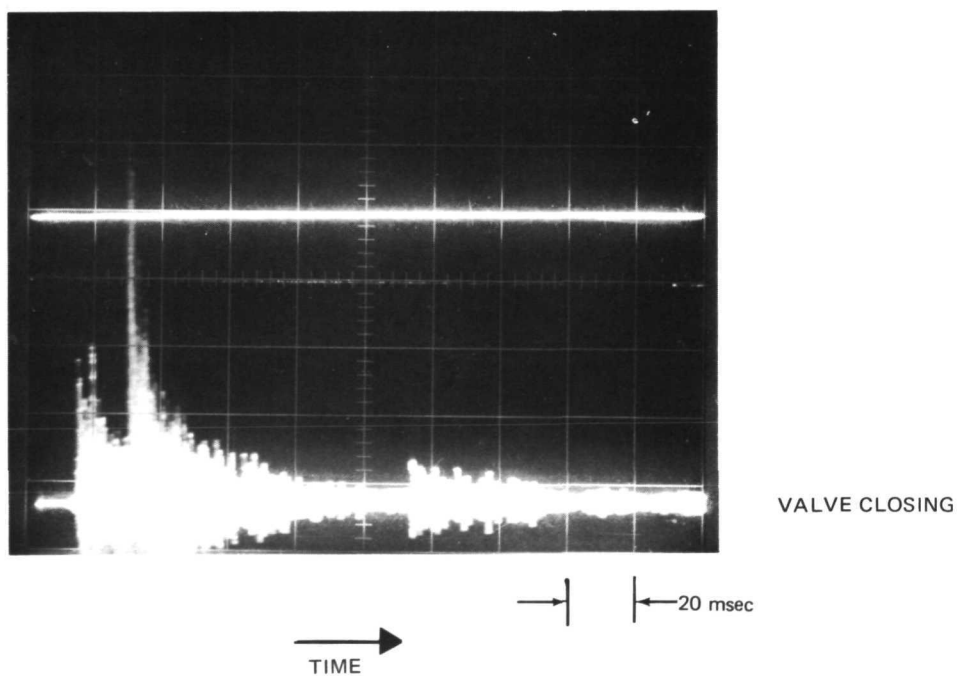
A complete set of monitoring photographs were taken with the acoustical signature equipment during completion of test 1-4. The vibrational envelopes recorded remained constant throughout the testing, as shown in Figures 3-23 through 3-26. Since both valves remained in good mechanical condition throughout the testing, there was no occasion to obtain a trace of a valve malfunction. It was found that the photographs taken on the oscilloscope

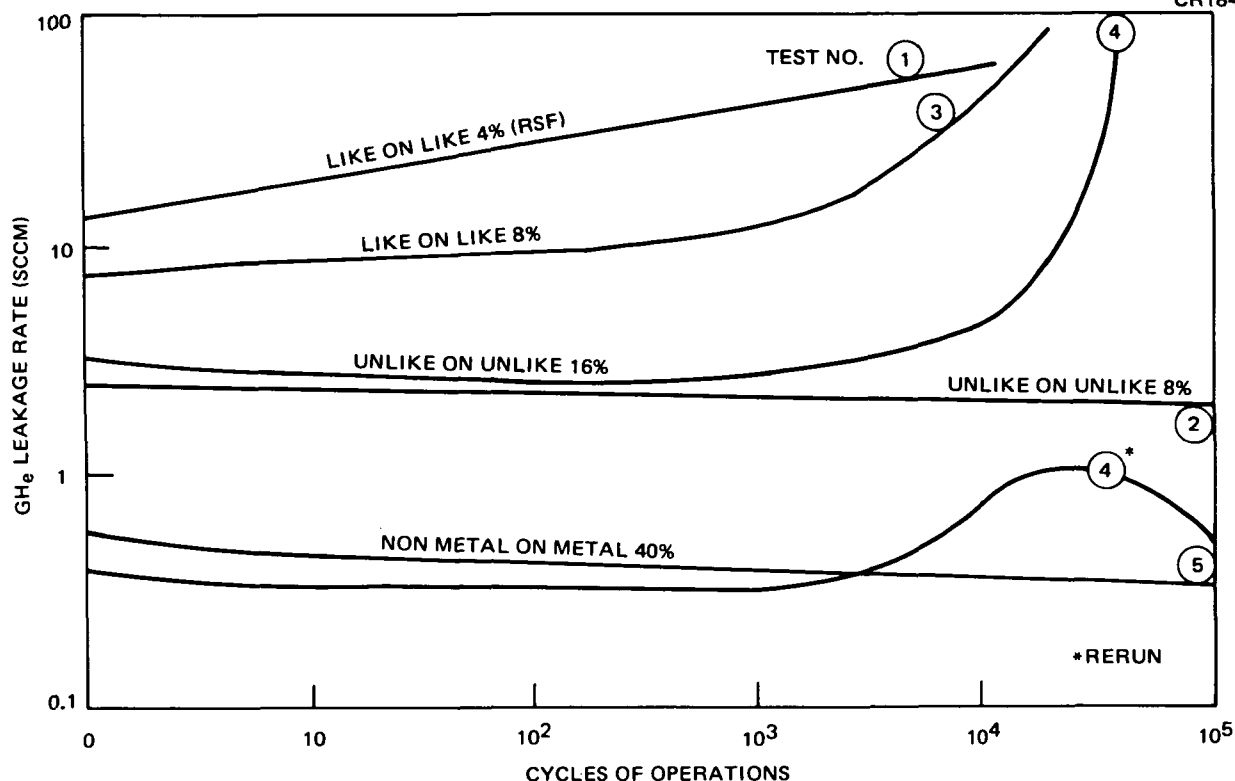
Figure 3-27. Cycle Life Characteristics in GH<sub>2</sub> Environment/Ambient Temperature/ $7 \times 10^5$  N/M<sup>2</sup> (100 psig)

The final test data plotted graphically for the Task I effort are shown in Figure 3-27. It should be noted that these data have not been normalized for initial leakage rates. The change in leakage with cycles will show the data of greatest interest. It should be noticed that the rerun of test No. 4 does not show the same loss of leakage control as was observed on the original test No. 4. This trend would indicate that the gold plating used on the original Test No. 4 was softer than the present plating, as had been expected. These data confirm the performance predicted for the hard gold-plated surface and indicate that the soft gold hardness measurements obtained by MDAC after the original Test No. 4 run was completed were a true indication of the hardness of the gold plating used for that test. Note that the original test specimen had been certified as hard gold plating by the vendor but measured in the soft gold range by MDAC. The specimen was apparently plated with soft gold.

- A. The Inconel 718-A286 material combination is not acceptable in  $\text{GH}_2$  when loaded in the  $2.7 \times 10^7$  to  $5.4 \times 10^7 \text{ N/m}^2$  (4,000 to 8,000 psi) seat stress range.
- B. The Inconel 718-Soft Gold material (Class 1, Grade A) had a cycle life of 25,000 cycles when loaded at  $3.3 \times 10^7 \text{ N/m}^2$  (4,800 psi) seat

- stress in GH<sub>2</sub>. This combination would appear acceptable for a design cycle life of 10,000 cycles (with a safety factor of 2.5) at this load level.

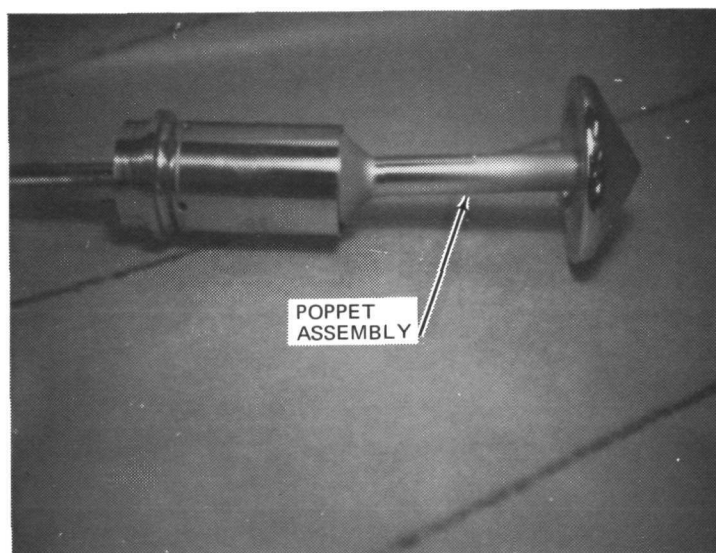
Figure 3-33. -501 Valve (Inconel) Poppet Assembly after First Contamination Test

The sealing surface of the poppet suffered very little damage, however, some of the shine was removed from this surface as shown in Figure 3-33.

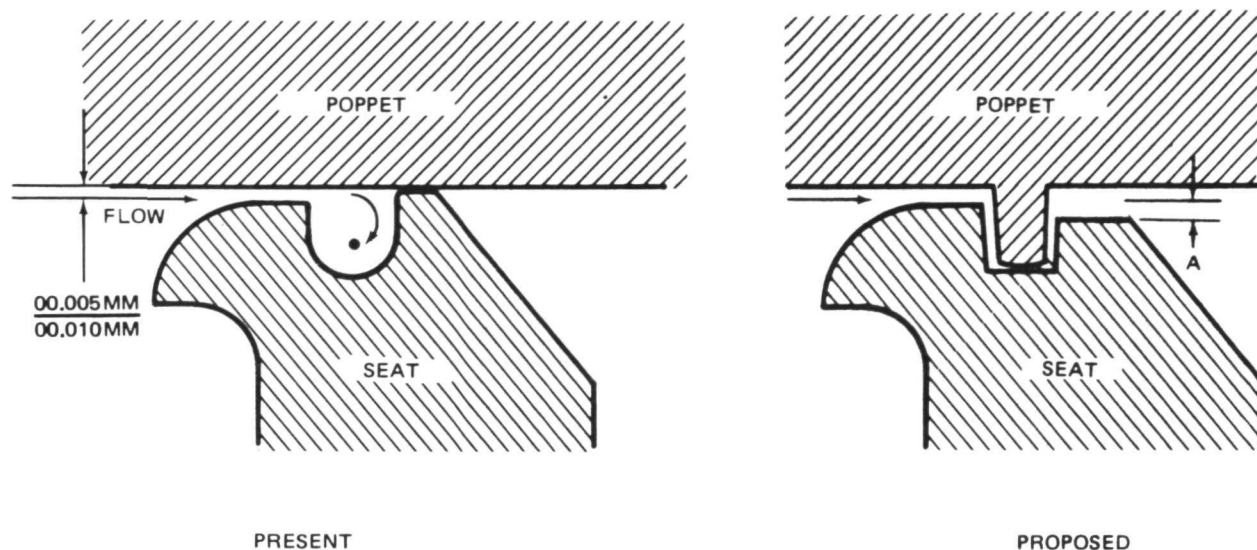
Figure 3-34. Present Design and Proposed Redesign Seal Closure Configuration

the gold plating and this particle remained embedded at the point of impact. This embedded particle was not completely embedded and apparently was preventing the proper loading on one side of the valve seat. This slight unloading of the seat sealing surface on one side of the seat appears to have caused the relatively small increase in leakage rate measured on this test. The embedded particle was in the 25  $\mu$  size range and appears to have been about 0.025 mm (0.001 in.) in diameter. Since the -501 valve seat has a gold plating which is less than half this amount 0.01 mm (0.0004 in.), it is understandable why the particle could not be embedded to a depth that would not have increased the leakage rate. Based on the results of this test, a gold plating of 0.025 mm (0.001 in.) would be indicated as an improvement in valve damage tolerance. However, since Test No. 1 indicates that better full flow performance would be expected by moving the raised seat portion of the sealing surface to the poppet (and mating this surface with a submerged surface in the seat assembly), it appears that no change in gold plating would be required for the modified valve design. The present design and the proposed redesign are shown in Figure 3-34.
